Influence of surface modification on the *in vitro* corrosion rate of magnesium alloy AZ31

Joy E. Gray-Munro, Christine Seguin, Michael Strong

Department of Chemistry and Biochemistry, Laurentian University, Sudbury, Ontario, Canada P3E 2C6

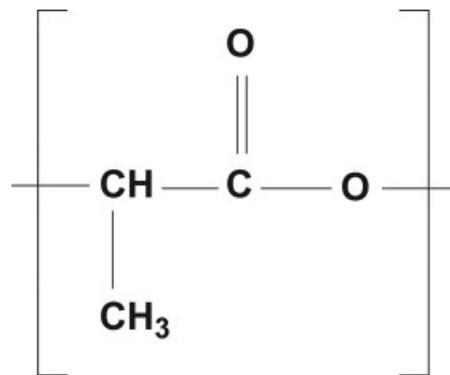
Figure 1. Chemical structure of poly(L-lactic acid) (PLA).

ferred for biomedical applications because hydrolysis results in the production of L(+)-lactic acid, which is found naturally in the body. Furthermore, the degradation products are nonacidic. PLA is of particular interest for orthopedic applications because it has been demonstrated that bone-like apatite can be deposited on PLA fibers.²² The structure of this polymer is shown in Figure 1.

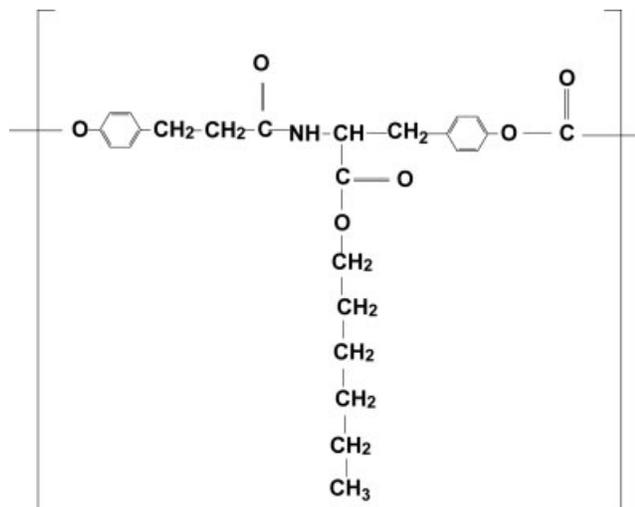
Figure 2. Chemical structure of poly(desaminotyrosyl tyrosine hexyl carbonate) [poly(DTH carbonate)].

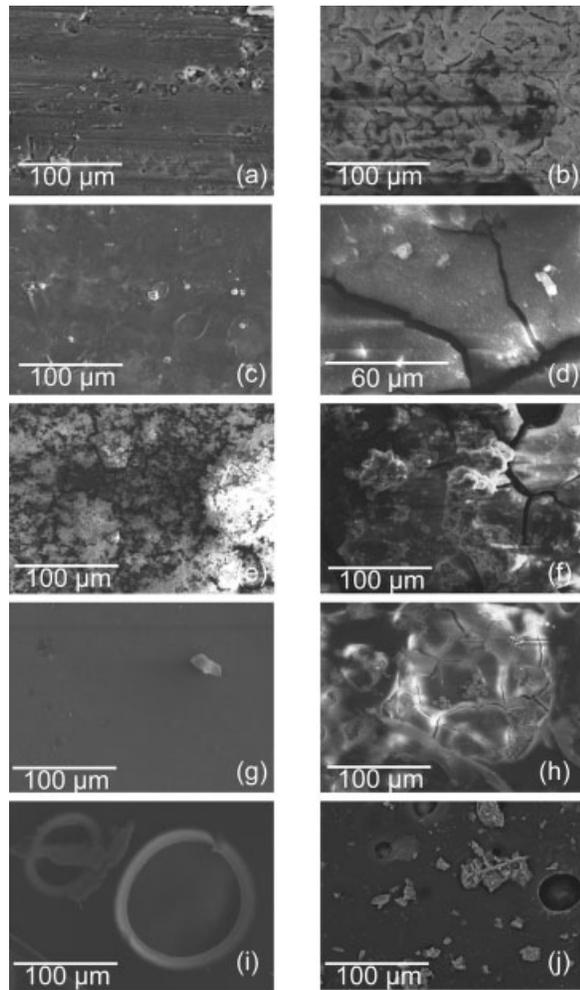
Figure 3. Scanning electron micrographs of magnesium alloy before and after corrosion in SBF at 37°C for 2 weeks; (a) solvent-degreased sample prior to corrosion, (b) solvent-degreased sample after corrosion, (c) acid-etched sample prior to corrosion, (d) acid-etched sample after corrosion, (e) calcium phosphate-coated sample prior to corrosion, (f) calcium phosphate-coated sample after corrosion, (g) PLA-coated sample prior to corrosion, (h) PLA-coated sample after corrosion, (i) poly(DTH carbonate)-coated sample prior to corrosion, and (j) poly(DTH carbonate)-coated sample after corrosion.

Acid etching is a common pretreatment in preparation for surface coating. Acid etching of magnesium alloys is believed to remove the gross scale that is produced during the manufacturing process and to replace the native oxide layer with a more passive oxide layer.²⁹ Figure 3 shows SEM images of a magnesium alloy coupon that has been solvent degreased [Fig. 3(a)] and a sample that has been etched in phosphoric acid [Fig. 3(c)]. It is clear from these images that prior to acid etching the sample surface has a nonuniform morphology with visible pits, whereas the acid-etched sample is much more homogeneous. To obtain coatings with minimum porosity and maximum adhesion a uniform surface is desirable.

Figure 3(b,d) shows SEM images of the clean and acid-etched magnesium alloys after corrosion in SBF, and Figure 5(b,d) shows the corresponding FTIR

Figure 3(e) is an SEM image of the calcium phosphate coating prior to corrosion in SBF. It is clear from this image that the coating is present as two distinct layers. The underlayer very closely resembles the calcium phosphate layer that we observed on the acid-etched samples after corrosion [Fig. 3(d)]. The formation of this layer is catalyzed by the anodic dissolution of the substrate as described earlier. The overlayer is calcium phosphate precipitates that form in solution via a homogeneous nucleation process as the pH of the coating bath rises over time.

SEM images of the poly(DTH carbonate)-coated samples before and after corrosion [Fig. 3(i,j)] show that the poly(DTH carbonate) coating prior to corrosion is relatively uniform with some circular structures. EDS analysis confirmed that these circular regions were actually polymer “droplets” and not

pores in the coating itself. After corrosion the SEM image clearly shows that the polymer film is largely intact with some precipitates deposited on top of the polymer surface.

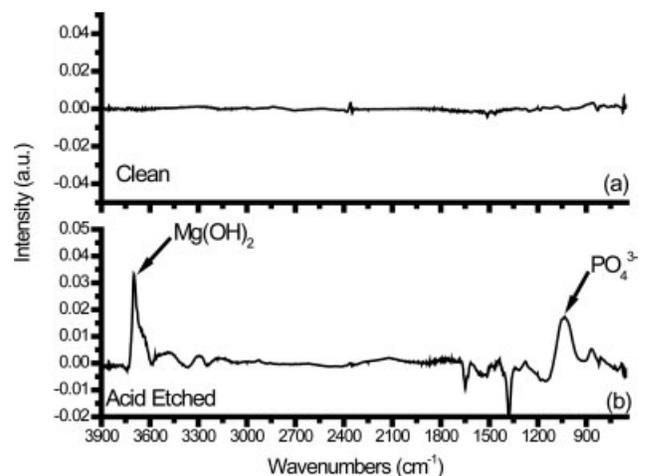
Figure 4. ATR-FTIR spectra of (a) solvent degreased (clean) and (b) acid-etched magnesium alloy coupons prior to corrosion.

Acid etching also results in significant changes in the surface chemistry of the magnesium alloy coupons. Figure 4 shows ATR-FTIR spectra for a magnesium alloy coupon before and after acid etching. Two new vibrational bands are observed in the infrared spectrum after etching. The new vibrational band at 3700 wavenumbers is the OH stretching vibration for magnesium hydroxide.³⁰ This compound readily forms at the surface of magnesium alloys due to exposure with air or aqueous solutions, particularly at higher pH values.³¹ Following the acid etching step the samples are neutralized in a solution of sodium hydroxide. It is likely that the magnesium hydroxide forms at this stage. The new vibrational band centered at 1030 cm^{-1} is due to the presence of phosphate on the etched surface and is most likely present as magnesium phosphate. Figure 5(c) shows the phosphate region of this spectrum in more detail. One broad band is observed between 900 and 200 cm^{-1} . This band represents the symmetric (ν_1) and antisymmetric (ν_3) stretching modes of phosphate.³² The fact that this band is broad and featureless is indicative of PO₄³⁻ in an amorphous

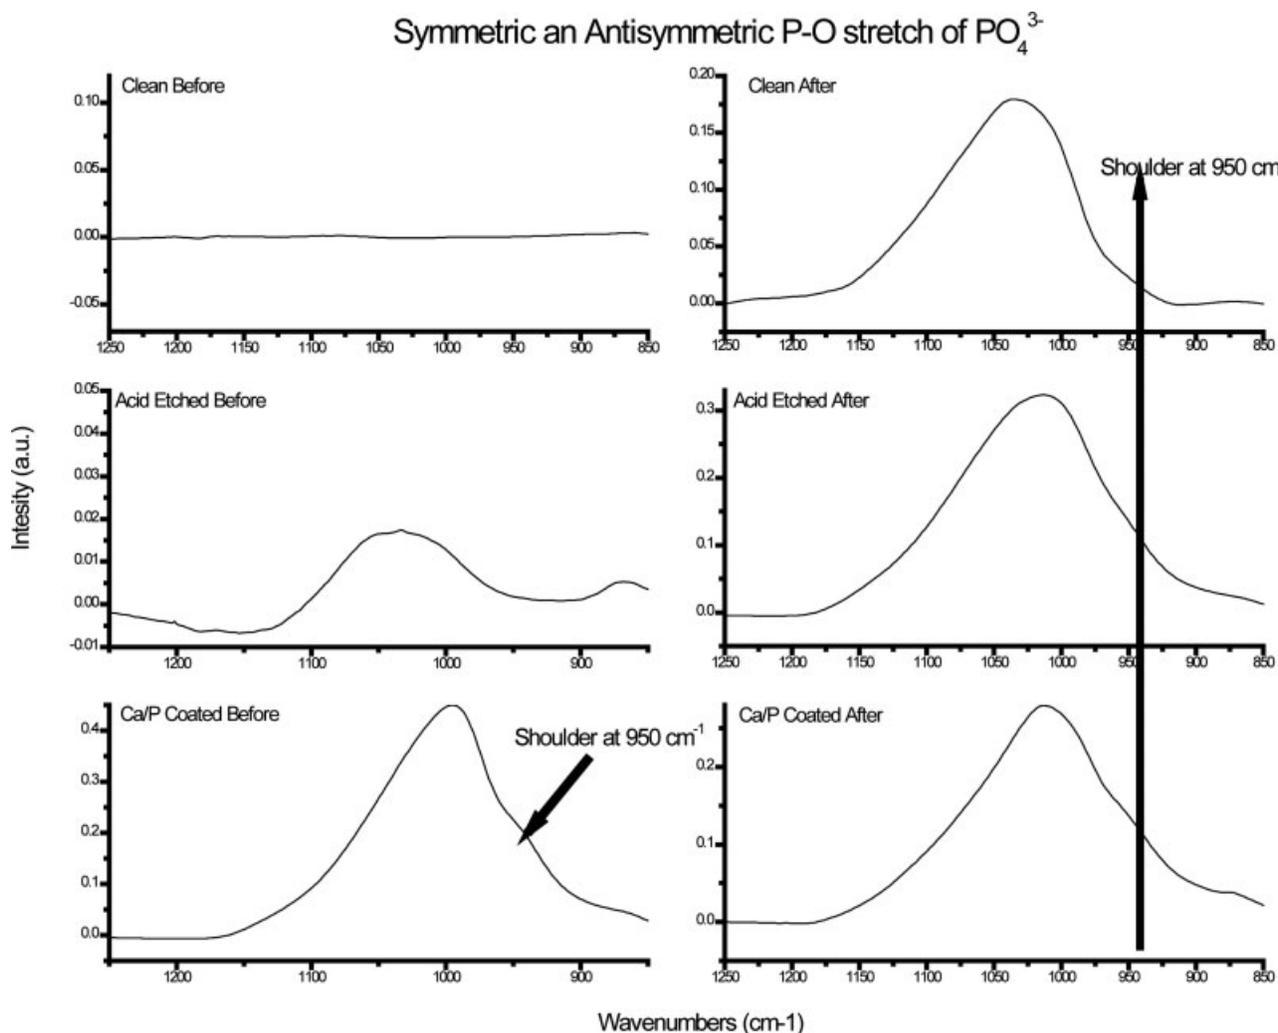
Figure 5. ATR-FTIR spectra of the phosphate region for cleaned, acid-etched, and calcium phosphate-coated samples before and after corrosion in SBF at 37°C for 2 weeks; (a) solvent-degreased sample prior to corrosion, (b) solvent-degreased sample after corrosion, (c) acid-etched sample prior to corrosion, (d) acid-etched sample after corrosion, (e) calcium phosphate-coated sample prior to corrosion, and (f) calcium phosphate-coated sample after corrosion.

spectra. The main feature in both the FTIR spectra is a large broad peak from 900 to 1200 cm^{-1} due to the P—O stretching vibrational modes. Calcium and phosphate ions are both present in the SBF solution. As the sample corrodes, the pH of the solution rises inducing precipitation of calcium phosphate onto the sample surface.

It has been shown that amorphous calcium phosphate has one large broad featureless band in this region. As the crystallinity of the calcium phosphate improves (i.e., as hydroxyapatite is formed), the observed peak becomes narrower and a high frequency shoulder emerges between 950 and 970 cm^{-1} .^{32,34} The IR spectrum for the clean sample after immersion in SBF shows one broad band with a very weak shoulder at about 950 cm^{-1} . This is consistent with the presence of very poorly crystalline HA at the surface. The poor crystallinity is to be expected due to the high corrosion rate of the

unmodified material and the fact that magnesium ions are a known crystal growth inhibitor for HA.³⁷ In contrast, the crystallinity of the calcium phosphate deposited on the corroded acid-etched sample is improved as evidenced by the increase in intensity of the ν_1 P—O stretch vibrational band at 950 cm^{-1} . Chemical analysis by EDS confirms the presence of both calcium and phosphorus on the surface of the corroded samples, confirming that calcium phosphate is deposited on the surface of the magnesium alloy during corrosion. Furthermore, the SEM images [Fig. 3(b,d)] indicate that the calcium phosphate layer that forms on the acid-etched sample is more uniform. The improved crystallinity and more uniform morphology of the calcium phosphate layer on the acid-etched sample can both be correlated to the slower corrosion rate of the acid-etched sample, a result of the magnesium phosphate/magnesium hydroxide layer that helps to protect the surface from corrosion. This means there is more time for heterogeneous nucleation and subsequent growth of the calcium phosphate crystals. Therefore, although both samples are partially passivated by the formation of a calcium phosphate film, the layer that forms on the acid-etched sample is more protective, resulting in a lower overall corrosion rate.

Acid-etched samples were immersed in a calcium phosphate coating bath for 2 weeks in order to pre-coat the magnesium alloy coupons with calcium phosphate. Figure 5(e) shows an ATR-FTIR spectrum for the calcium phosphate coating. The main feature in this FTIR spectrum is a large broad peak between 900 and 1200 cm^{-1} with a distinct shoulder at 950 cm^{-1} . As previously discussed this is indicative of the presence of poorly crystalline hydroxyapatite ($\text{Ca}_{10}(\text{PO}_4)_6(\text{OH})_2$).^{32,34} Our previous studies on the deposition of calcium phosphate coatings on magnesium alloys have shown that the mechanism of apatite deposition on the magnesium alloy substrate can be summarized by the following three reactions²⁶:

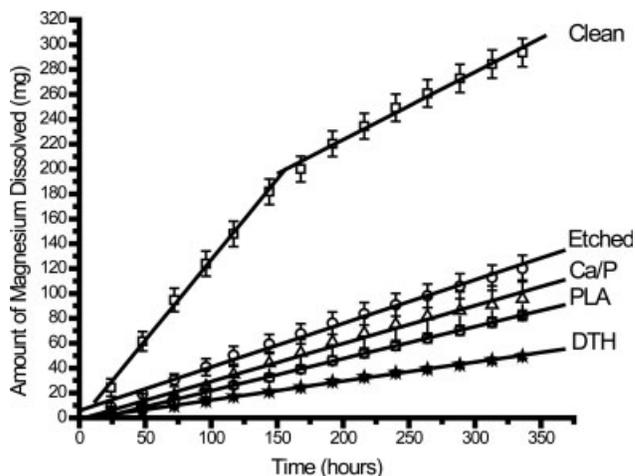
Figure 6. Amount of magnesium dissolved as a function of immersion time in SBF at 37°C for solvent-degreased (clean), acid-etched, calcium phosphate-coated, PLA-coated, and poly(DTH carbonate)-coated magnesium alloy coupons.

Figure 6 is a graph of the total mass of magnesium dissolved into the SBF solution as a function of immersion time in the bath. A steep rise in the concentration of dissolved magnesium in the bath is observed in the first 150 h (6 days) for the nonacid-etched (clean) samples. This steep rise represents a corrosion rate of 31 mg/day in the initial stages of corrosion, whereas in the latter stages the corrosion rate slows to 14 mg/day. The observed decrease in the corrosion rate indicates that the alloy becomes somewhat passivated, likely because of the deposition of a surface film on the alloy. The corrosion rate for the acid-etched sample (9 mg/day) is substantially lower than that of the nonacid-etched samples. Furthermore, the corrosion rate is constant for the duration of the study. It is obvious from this graph that acid etching results in a dramatic improvement in corrosion resistance of the magnesium alloy in SBF.

Figure 6 shows a graph of the total mass of magnesium dissolved into the SBF solution as a function of immersion time in the bath for calcium phosphate-coated samples. The overall *in vitro* corrosion for the calcium phosphate-coated samples is constant with a corrosion rate of $\sim 7\text{ mg/day}$. This is only slightly less than the 9 mg/day corrosion rate that was observed for samples that have not been pre-coated with calcium phosphate. An SEM image of the calcium phosphate-coated magnesium coupon after corrosion in SBF for 2 weeks is shown in Figure 3(f). Prior to corrosion the coating had a double layer structure. After corrosion only one layer is observed. The fact that the previously observed overlayer of calcium phosphate precipitates disappears suggests that dissolution of the overlayer occurs in the early stages of immersion in the SBF bath. The dissolution of the coating is followed by film growth as evidenced by the increase in Ca/Mg ratio measured by EDS. These results show that the Ca/Mg ratio increases from 1.01 prior to corrosion to 18.2 after corrosion; this indicates that the thickness of the calcium phosphate layer has increased significantly. The ATR-FTIR spectrum [Fig. 5(f)] again shows a large broad peak between 900 and 1200 cm^{-1} with a distinct shoulder at 950 cm^{-1} , indicating that the calcium phosphate film is poorly crystalline hydroxyapatite ($\text{Ca}_{10}(\text{PO}_4)_6(\text{OH})_2$).^{32,34}

mers, have nontoxic degradation products, and have been shown to induce calcium phosphate deposition *in vivo*.²⁴ Figure 6 is a graph of the total mass of magnesium dissolved into the SBF solution as a function of immersion time in the bath for the polymer-coated samples. The overall *in vitro* corrosion for both the polymer-coated samples is constant with a corrosion rate of ~5.6 mg/day for PLA and 3.5 mg/day for poly(DTH carbonate). In comparison with uncoated acid-etched samples the PLA and poly(DTH carbonate) coatings decrease the corrosion rate of the magnesium alloy by a factor of 2 and 3, respectively.

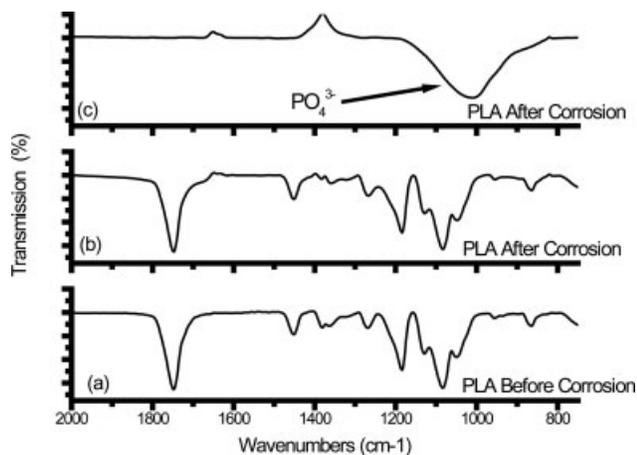
Figure 7. ATR-FTIR spectra of PLA-coated magnesium alloy coupons before and after corrosion in SBF at 37°C for 2 weeks; (a) prior to corrosion, (b) region 1 after corrosion, and (c) region 2 after corrosion.

The ATR-FTIR spectra for the PLA-coated magnesium coupons before and after corrosion are shown in Figure 7. Infrared spectra were obtained for three different corroded samples in multiple areas on each sample. Two very different infrared spectra were obtained depending on the area of the corroded sample that was analyzed. In Figure 7(b), there is no difference in the IR spectra for PLA after corrosion compared with the polymer prior to corrosion. This indicates that the polymer coating has not degraded in this region. In Figure 7(c), all of the polymer peaks have disappeared. One large broad peak between 900 and 1200 cm^{-1} with a distinct shoulder at 950 cm^{-1} is observed which is again consistent with that of the phosphate band in poorly crystalline hydroxyapatite. Chemical analysis by EDS confirms the presence of both calcium and phosphorus on the corroded sample. The infrared data suggest that the degradation of the coating is nonuniform. SEM images of the PLA-coated samples before and after corrosion [Fig. 3(g,h)] show that the PLA coating prior to corrosion is a uniform layer, whereas after corrosion it is obvious that pores have formed in the coating. The morphology of the corroded regions

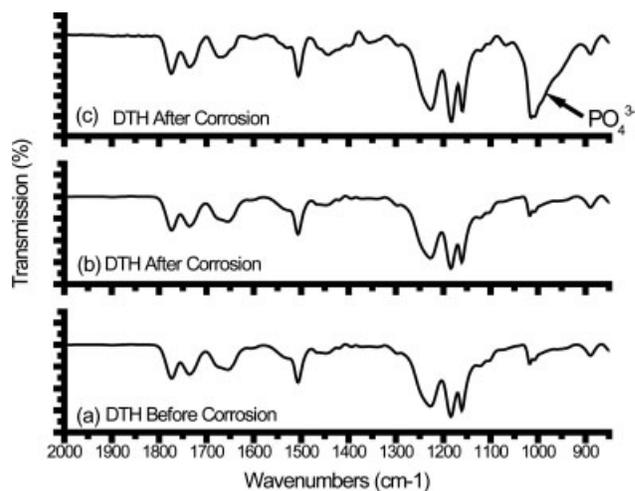
Figure 8. ATR-FTIR spectra of poly(DTH carbonate)-coated magnesium alloy coupons before and after corrosion in SBF at 37°C for 2 weeks; (a) prior to corrosion, (b) region 1 after corrosion, and (c) region 2 after corrosion.

The ATR-FTIR spectra for poly(DTH carbonate)-coated magnesium coupons before and after corrosion are shown in Figure 8. Infrared spectra were obtained for three different corroded samples in multiple areas on each sample. Two different infrared spectra were observed depending on the area of the corroded sample that was analyzed. In Figure 8(b), there is no difference in the IR spectra for poly(DTH carbonate) after corrosion compared with the polymer prior to corrosion. This indicates that the polymer coating has not degraded significantly in this region. In Figure 8(c), the infrared spectrum is almost identical to that of the noncorroded sample. However, there is one important change, a new large broad between 900 and 1200 cm^{-1} with a distinct shoulder at 950 cm^{-1} large broad is observed, which is consistent with the phosphate band in poorly crystalline hydroxyapatite. Chemical analysis by EDS confirms the presence of both calcium and phosphorus on the surface of these samples. The fact that the phosphate band is superimposed on the characteristic infrared spectrum of the polymer implies that the calcium phosphate has precipitated on top of the polymer coating.

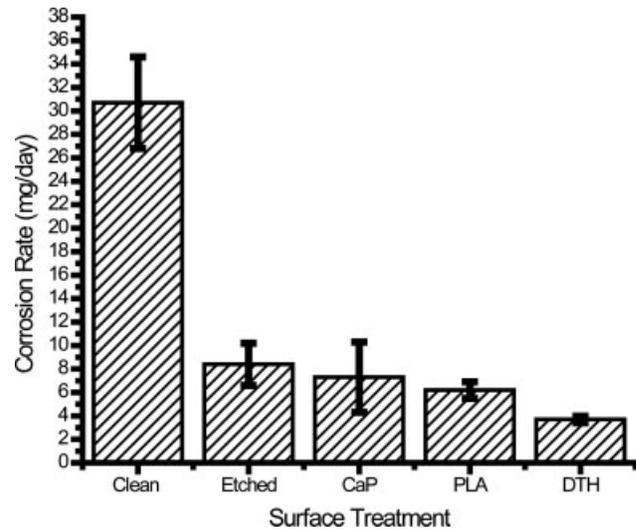
Figure 9. Summary of corrosion rates for all surface-modified magnesium alloy samples.

Figure 9 compares the corrosion rates of all of the surface modification strategies employed in this

study. The comparison reveals that the corrosion rates of the surface-treated magnesium alloys decreased in the following order:
